Protrk was contracted to remediate exterior ADA barriers identified on a CASp report. Challenged by project specific parking allowance built in to the site when constructed, Protrk borrowed slivers of space from landscape areas and adjacent stalls to achieve the required ADA parking count in the commercial service areas.

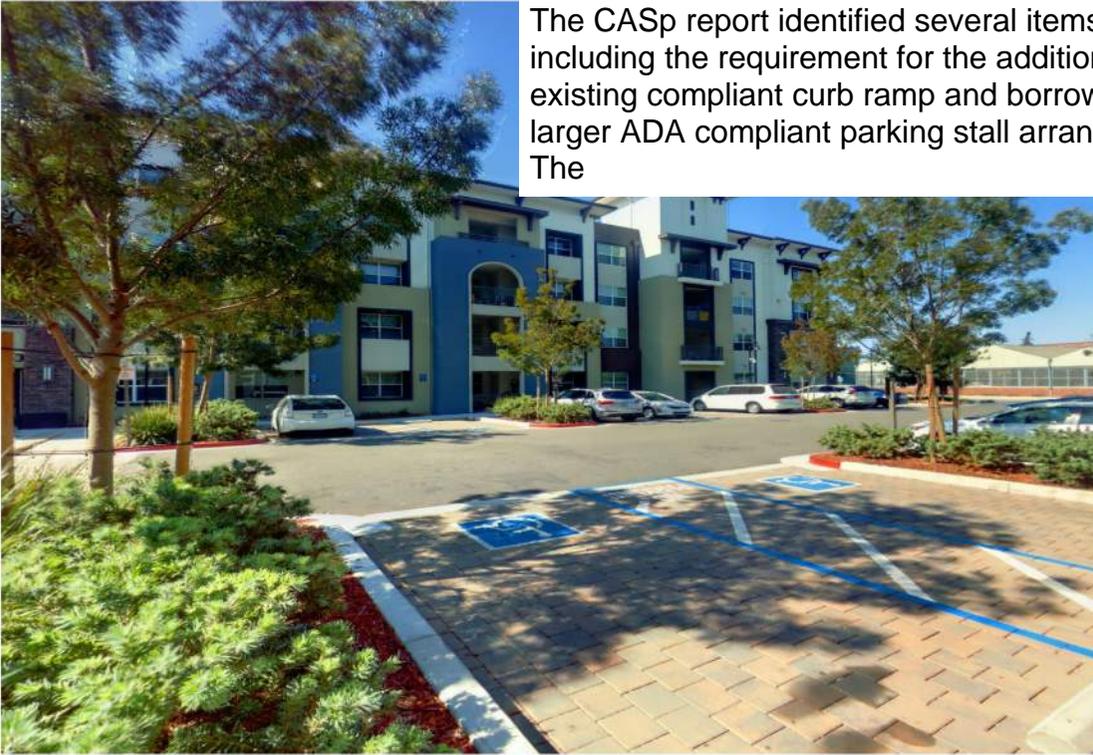
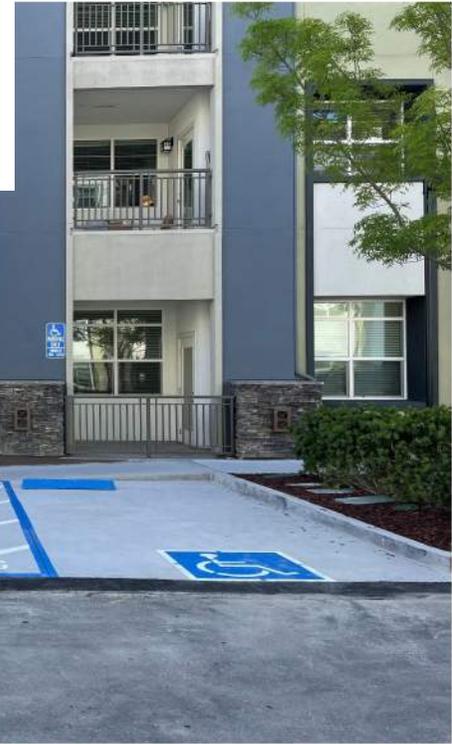
The CASp report identified several items for remediation at the existing parking stalls, including the requirement for the addition of a van stall. Protrk's solution utilized the existing compliant curb ramp and borrowed from an adjacent planting area to create the larger ADA compliant parking stall arrangement with no impact to overall parking count. The

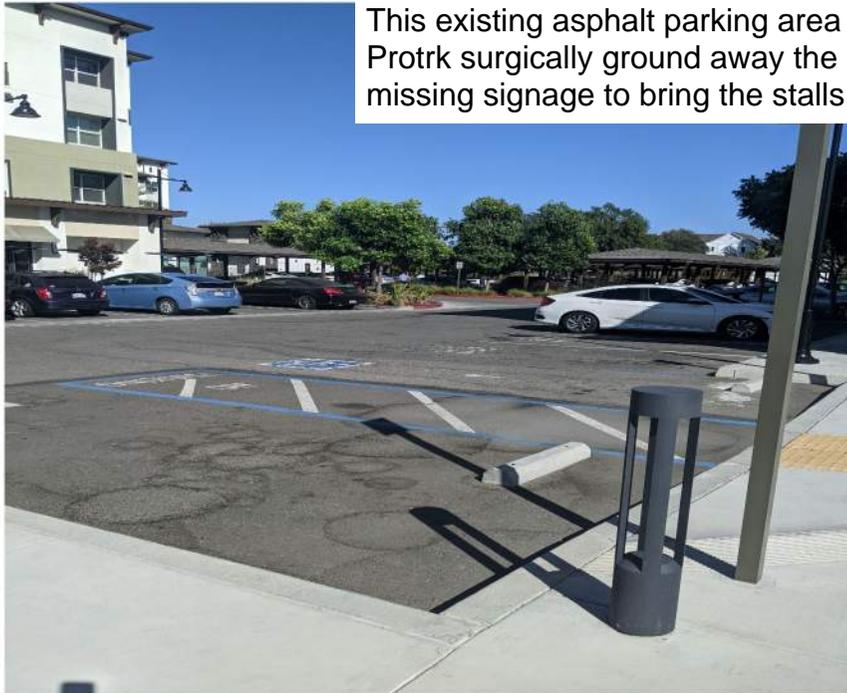
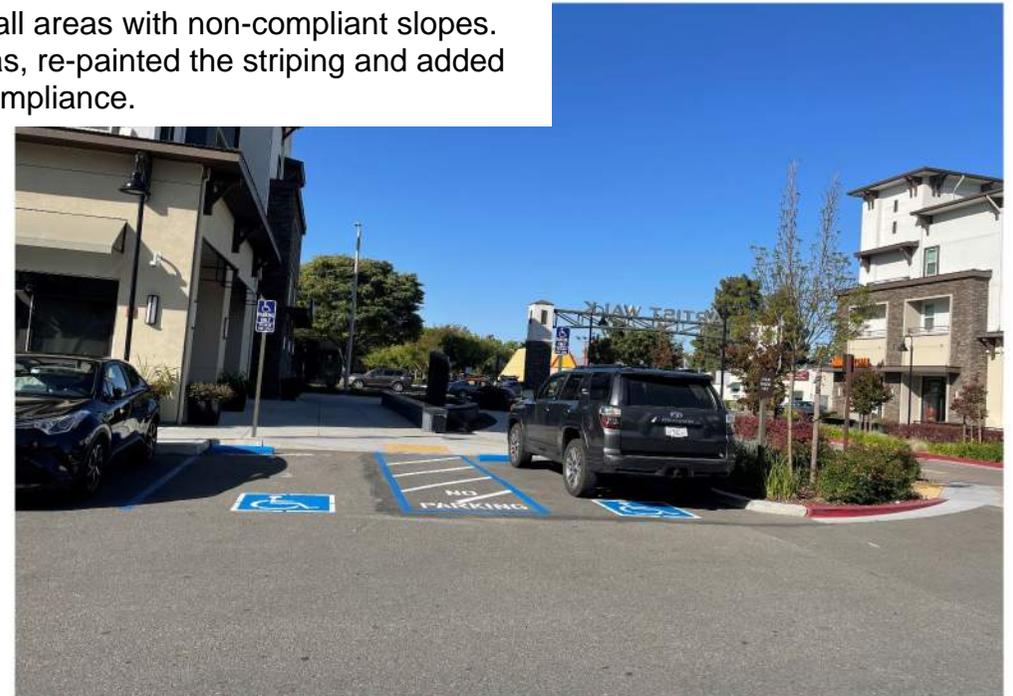
This existing asphalt parking area contained small areas with non-compliant slopes. Protrk surgically ground away the offending areas, re-painted the striping and added missing signage to bring the stalls to full ADA compliance.

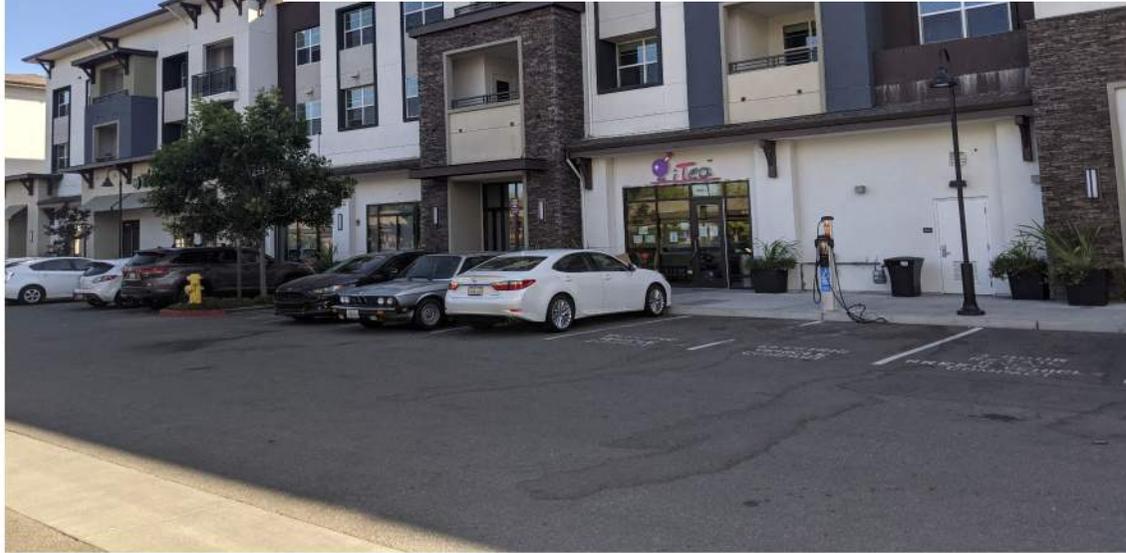
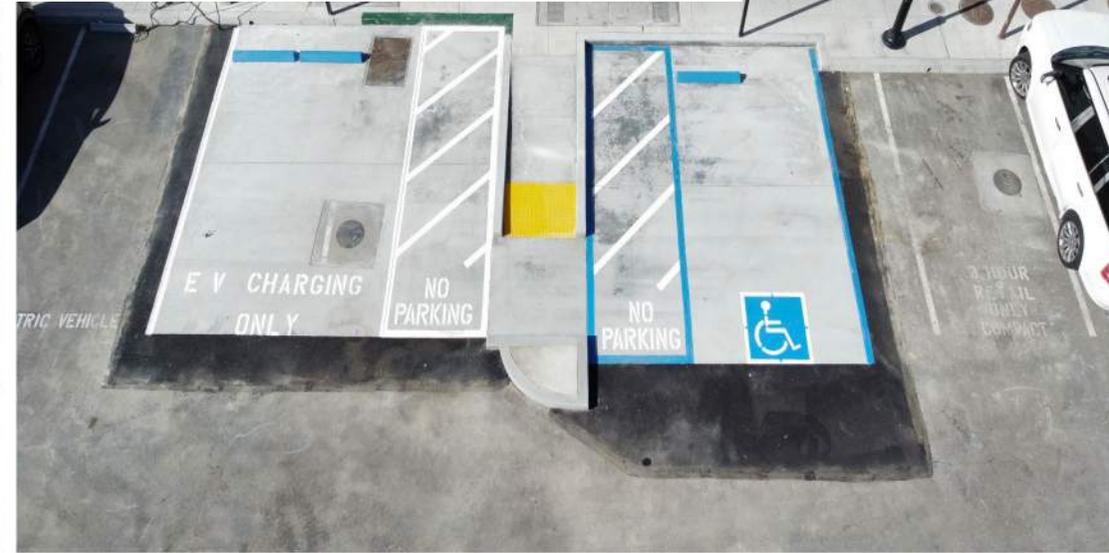
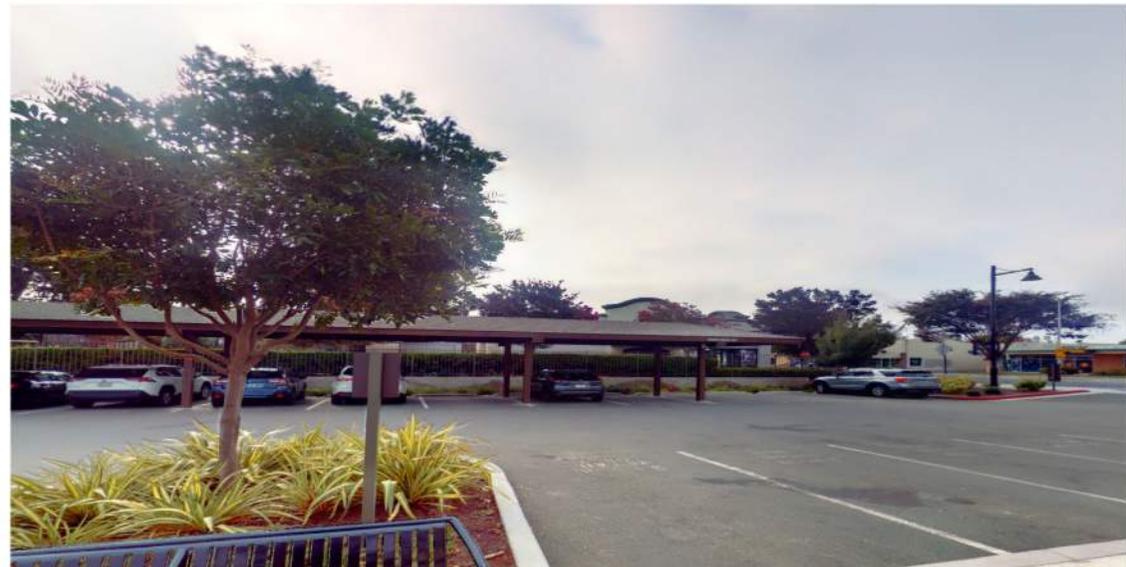
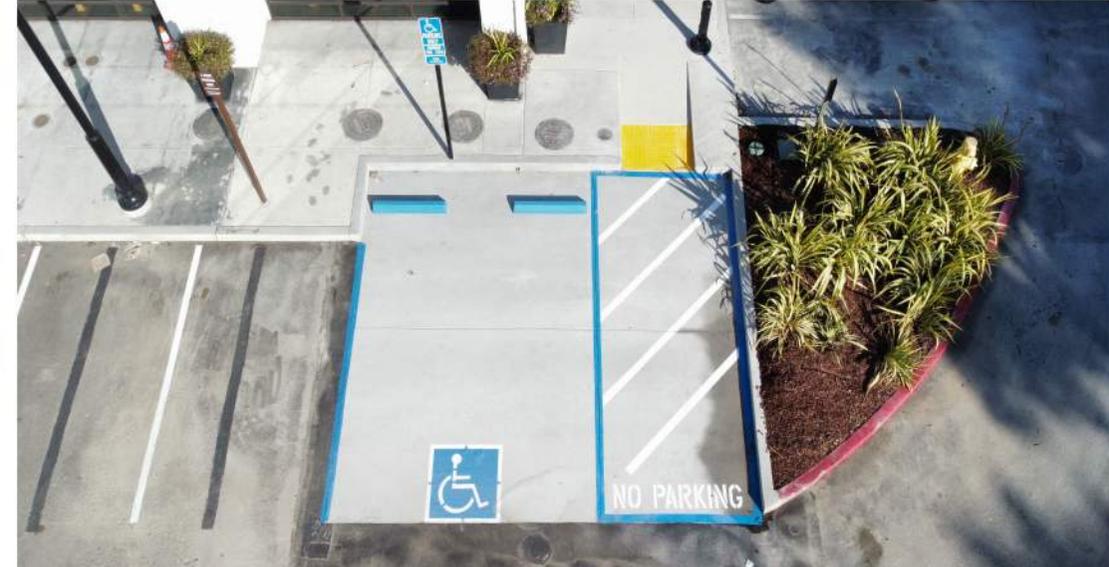
The CASp report for this property noted the existing EV charger did not serve an ADA stall and also identified the need for an additional standard ADA compliant stall in this retail area. The existing walks were full of existing utility access areas, eliminating the possibility of a curb ramp contained within it to serve the new ADA stalls. Protrk consolidated space by creating a shared curb ramp between the new ADA stalls, efficiently providing access for either use.

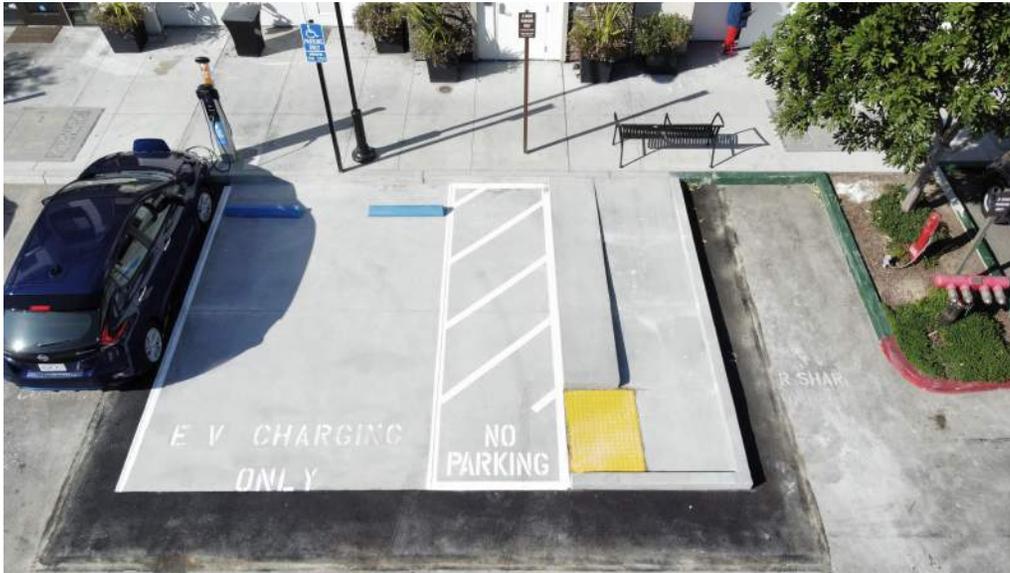
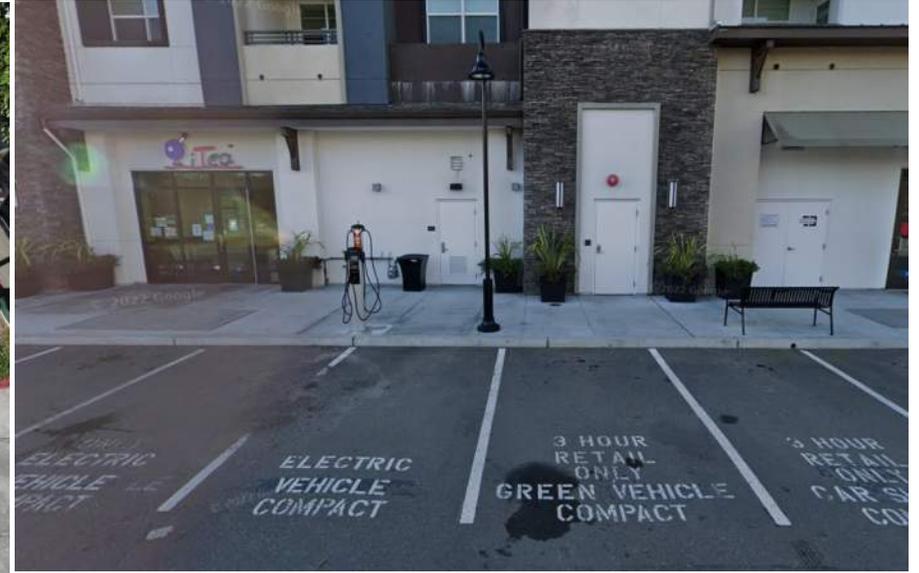
A specific retail area on this compactly designed campus required an additional ADA van stall. Protrk identified an area between numerous existing sidewalk utilities to carve out for the new van stall. We borrowed a small sliver of landscape area to minimize its impact on the overall parking count in the area.

The EV charging stall was not ADA compliant. Protrk borrowed space from an adjacent stall to create the required ADA compliant van stall and curb ramp.

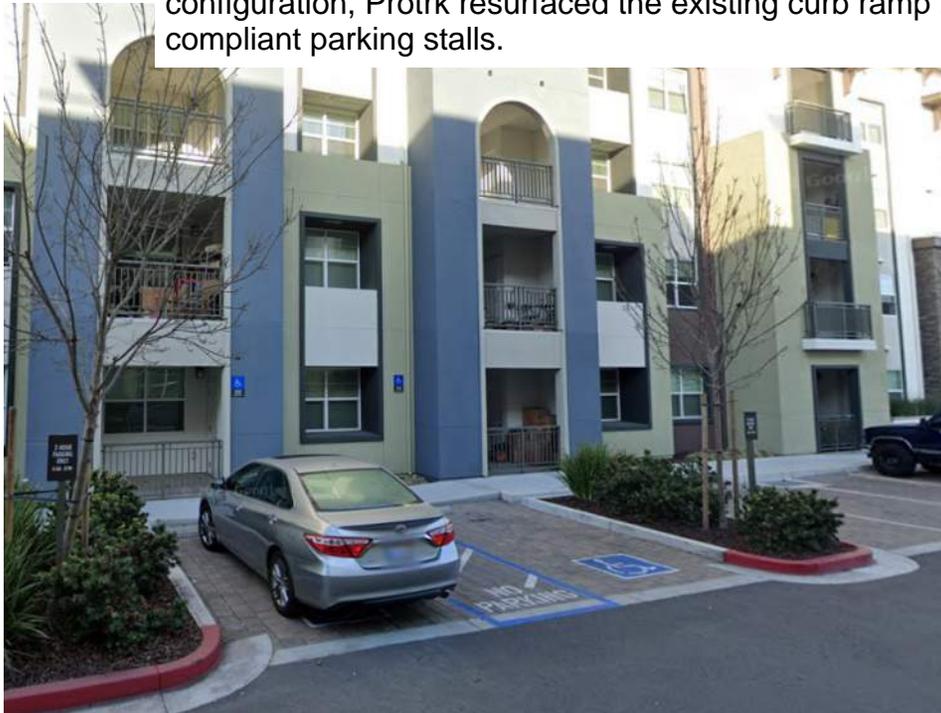
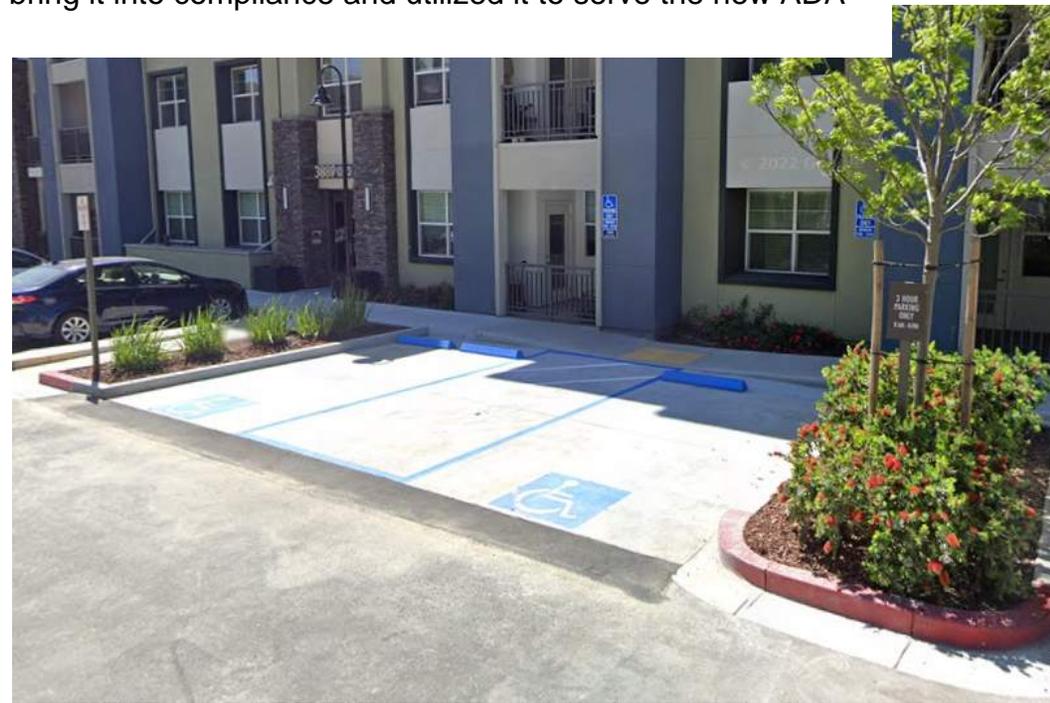
Almost a mirror image of its neighbor across the drive aisle, this ADA parking area was non compliant. With a similar configuration, Protrk resurfaced the existing curb ramp to bring it into compliance and utilized it to serve the new ADA compliant parking stalls.

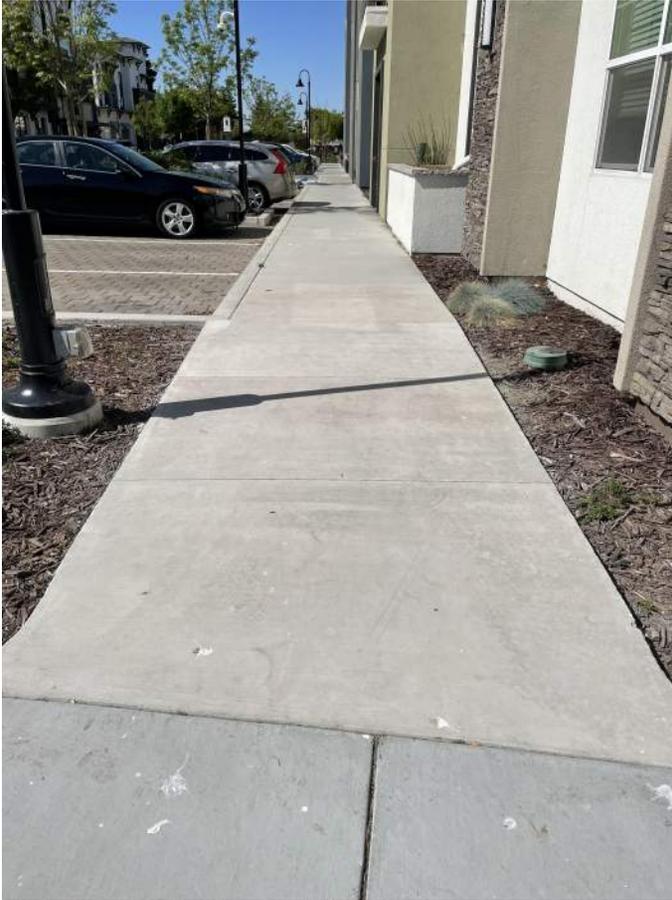
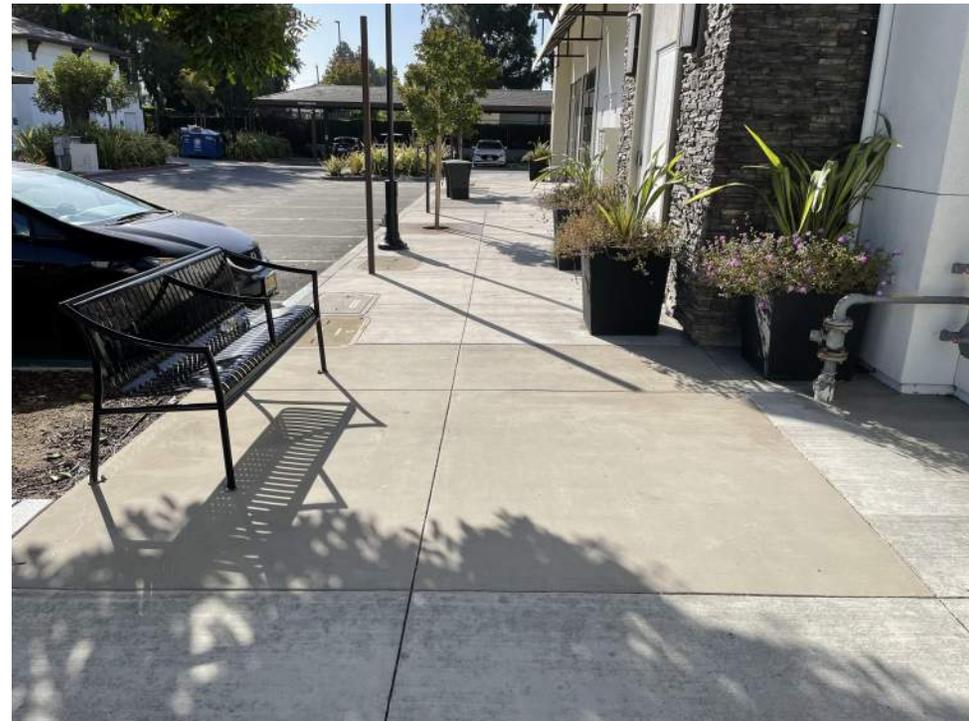
The CASp report identified certain areas of concrete walk throughout the site that were not ADA compliant. Protrk performed a full analysis of the site and remediated the slopes through our propriety resurfacing process, saving the owners countless dollars in concrete walk replacement.
