Protrk was contracted by this neighborhood grocery store owners to provide ADA compliant access and parking. The existing grades and storm water drainage patterns required an extended modification and repair of the asphalt drive aisle. Protrk capitalized on the this by manipulating the grades to create a loading area that provides a safe, level surface for deliveries to be dropped off, turning a site challenge into an opportunity for the owner.

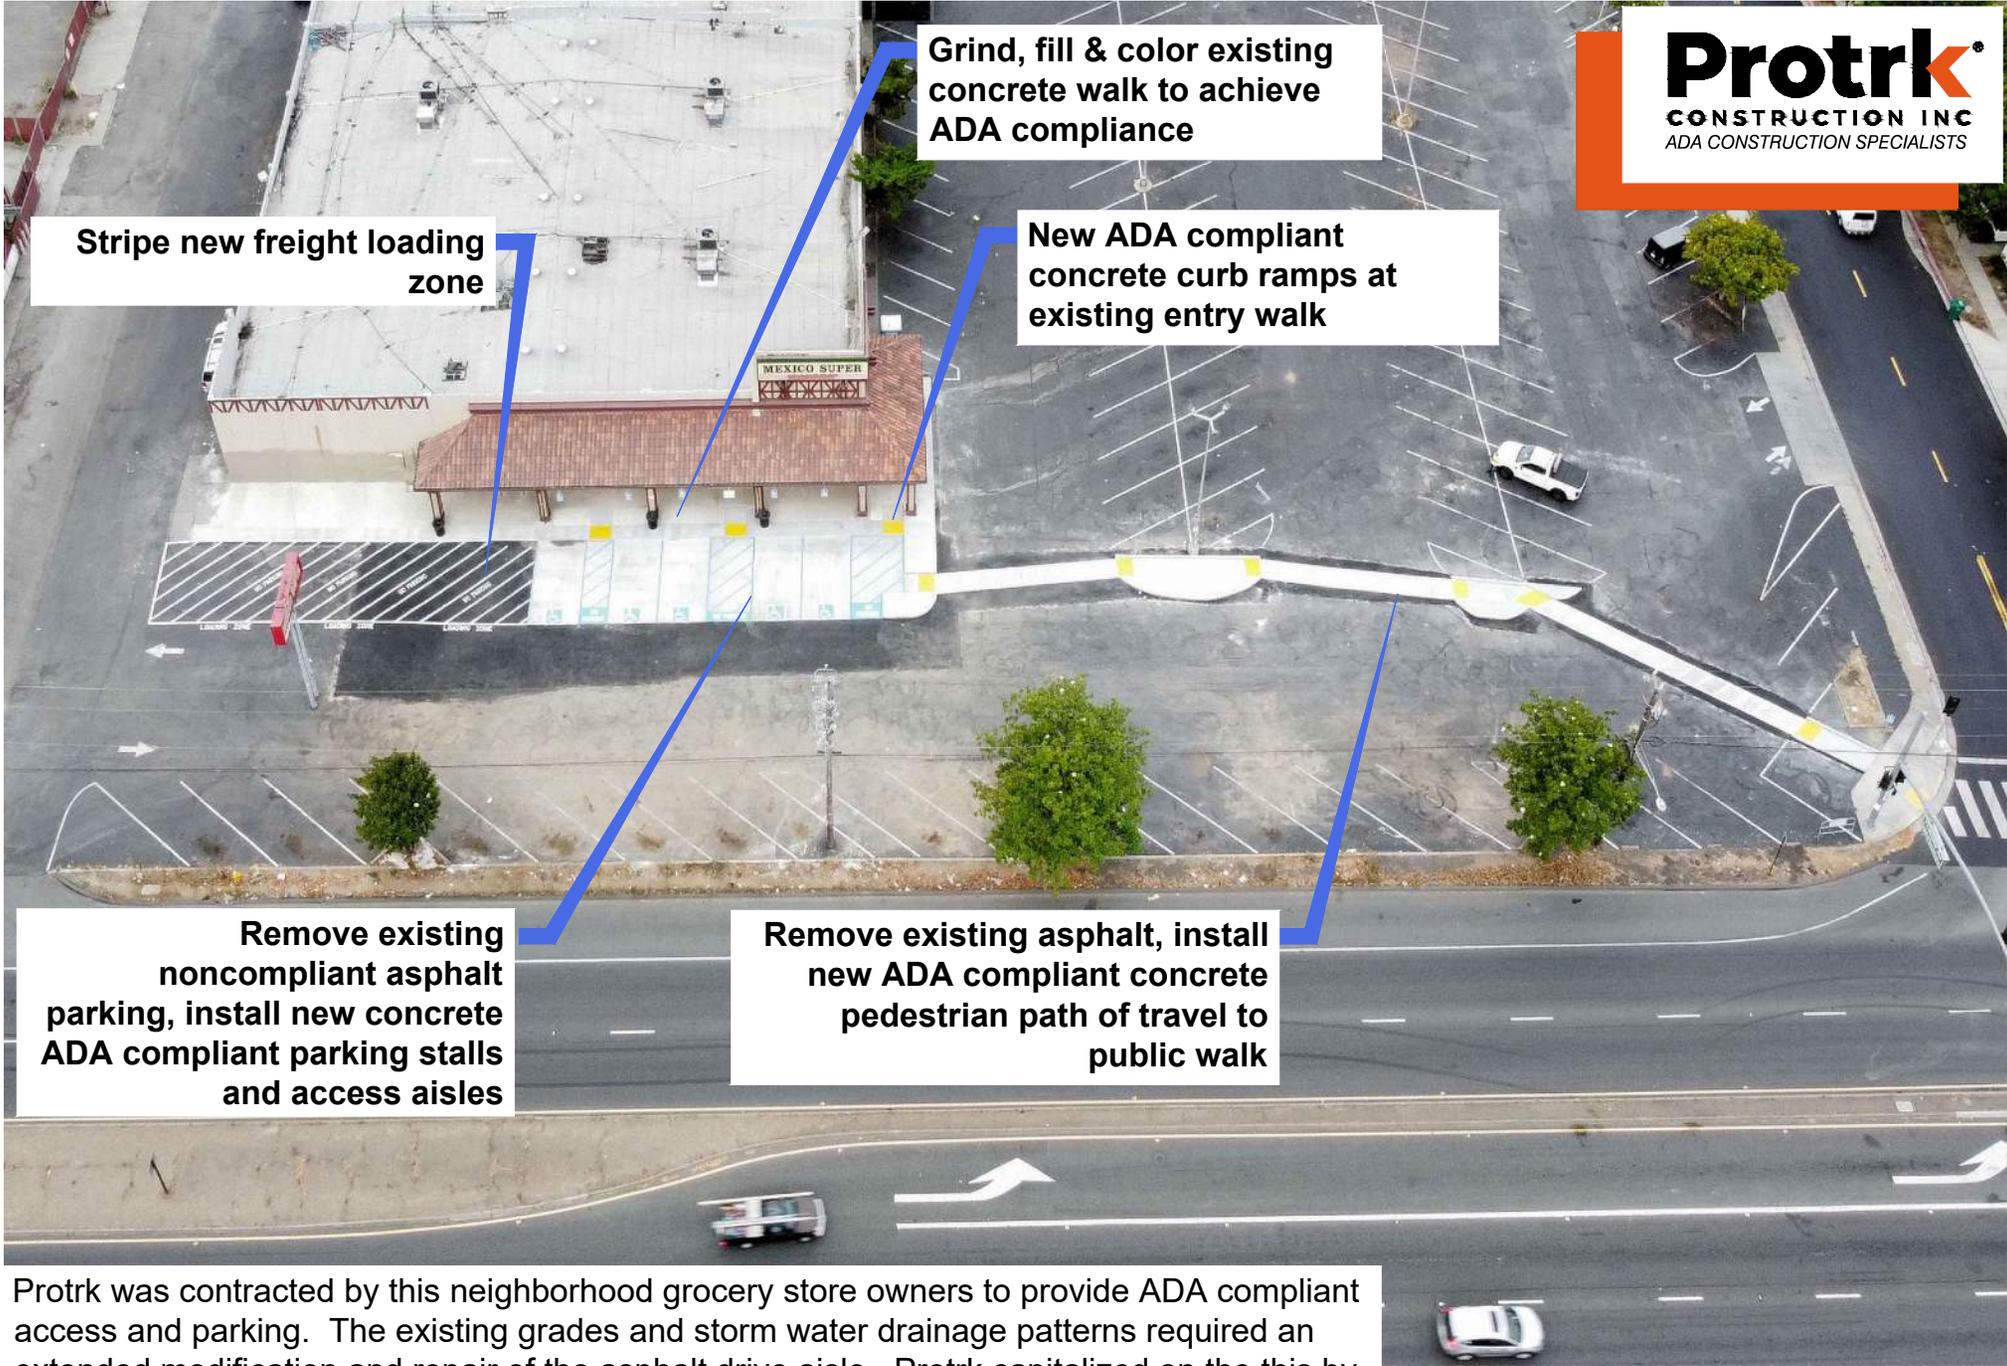
Stripe new freight loading zone

Grind, fill & color existing concrete walk to achieve ADA compliance

New ADA compliant concrete curb ramps at existing entry walk

Remove existing noncompliant asphalt parking, install new concrete ADA compliant parking stalls and access aisles

Remove existing asphalt, install new ADA compliant concrete pedestrian path of travel to public walk

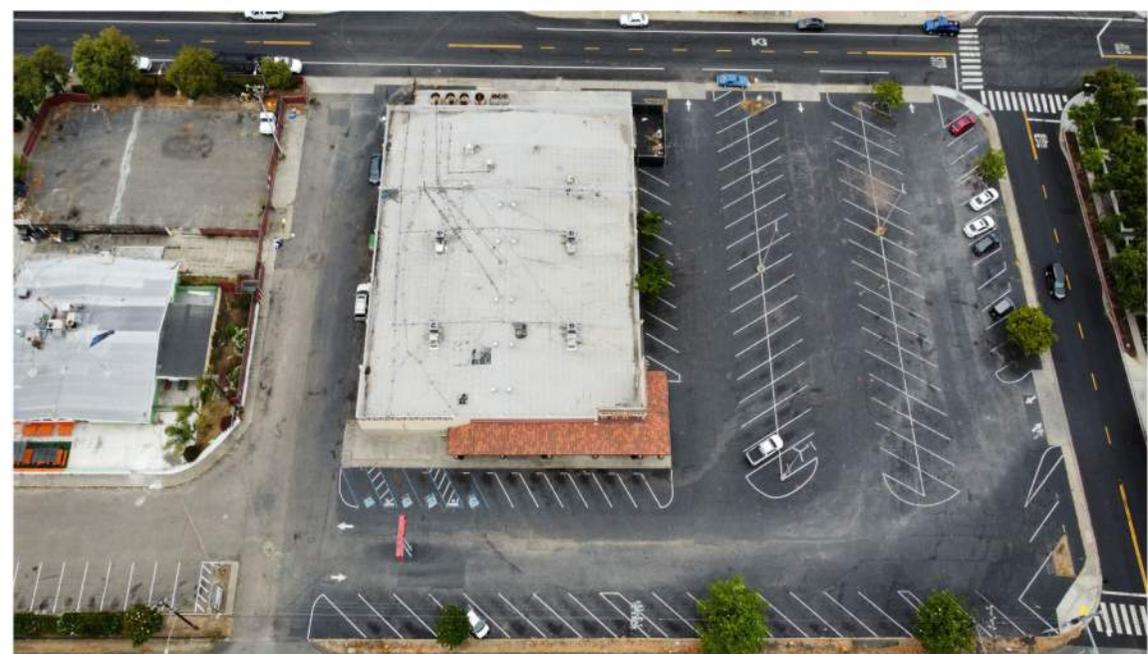
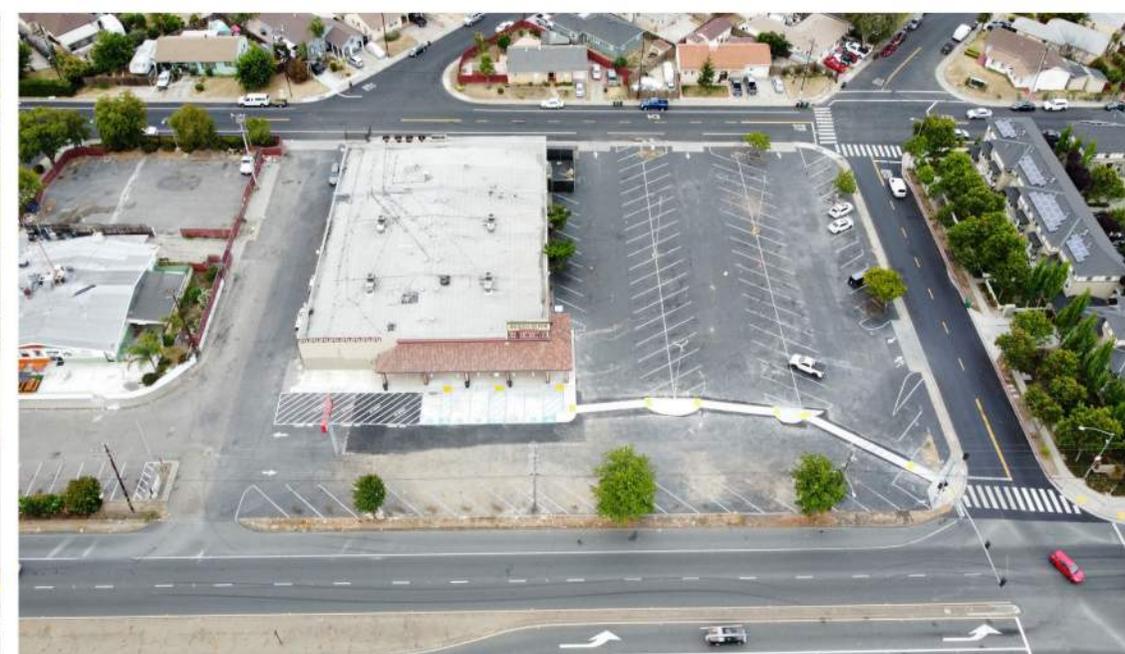
The existing non-compliant asphalt HC van stalls had several issues. Protrk relocated the ADA compliant stalls closest to the main entrance. We saved the owner the inconvenience and expense of replacing the entry walk through our proprietary grind, fill and color match process to achieve ADA complaint slopes. The existing concrete walk was modified to provide ADA compliant curb ramps to the new ADA compliant parking.

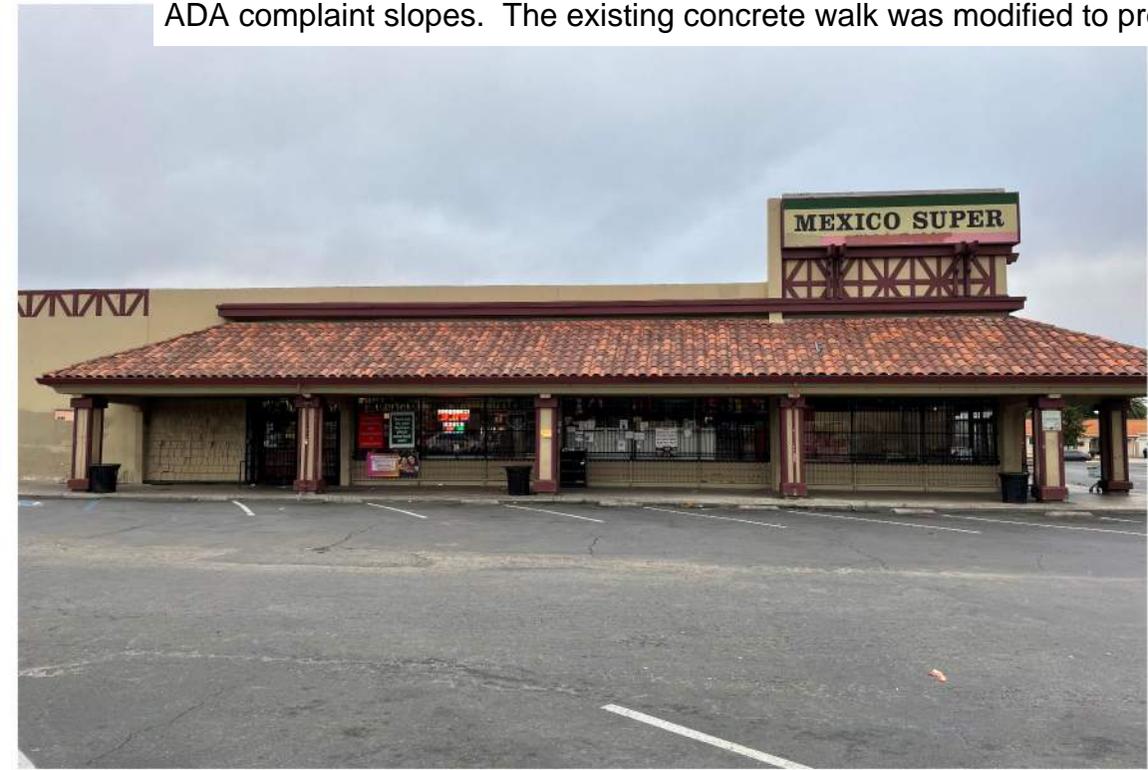
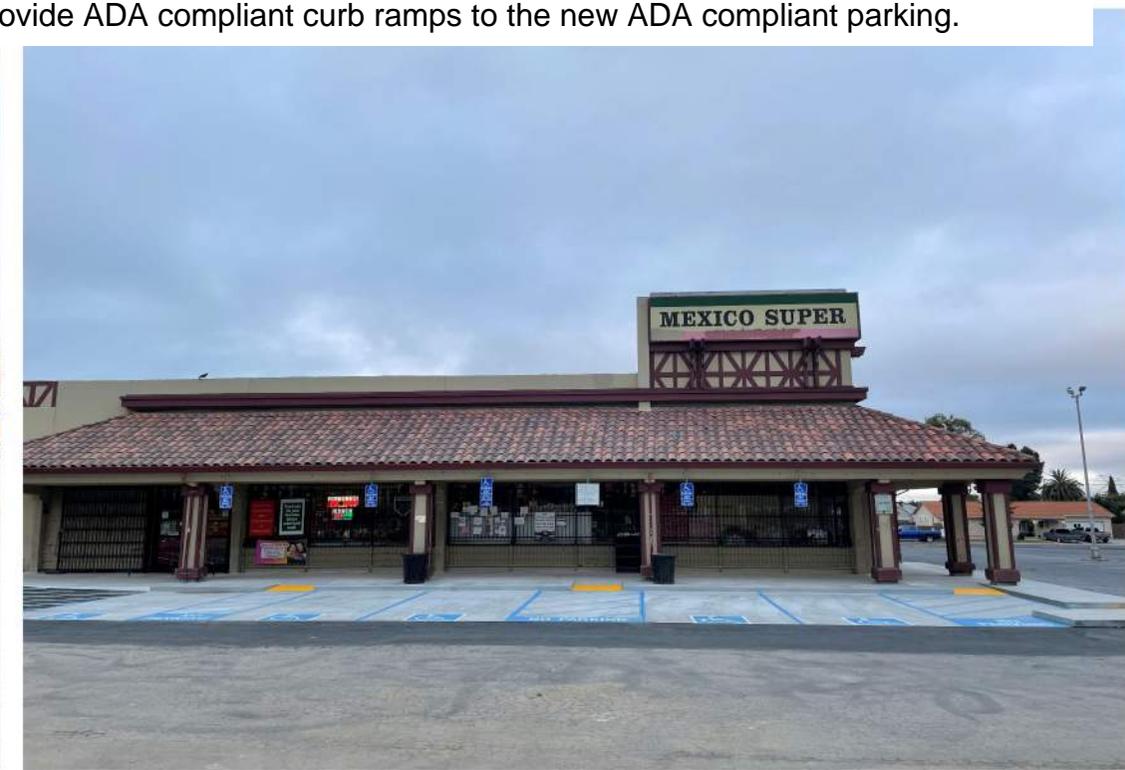
The existing concrete walk was made be to ADA compliant through Protrk's proprietary leveling technique, which also includes a coloring process so the remediation area, the new concrete and the existing concrete are uniform in appearance.

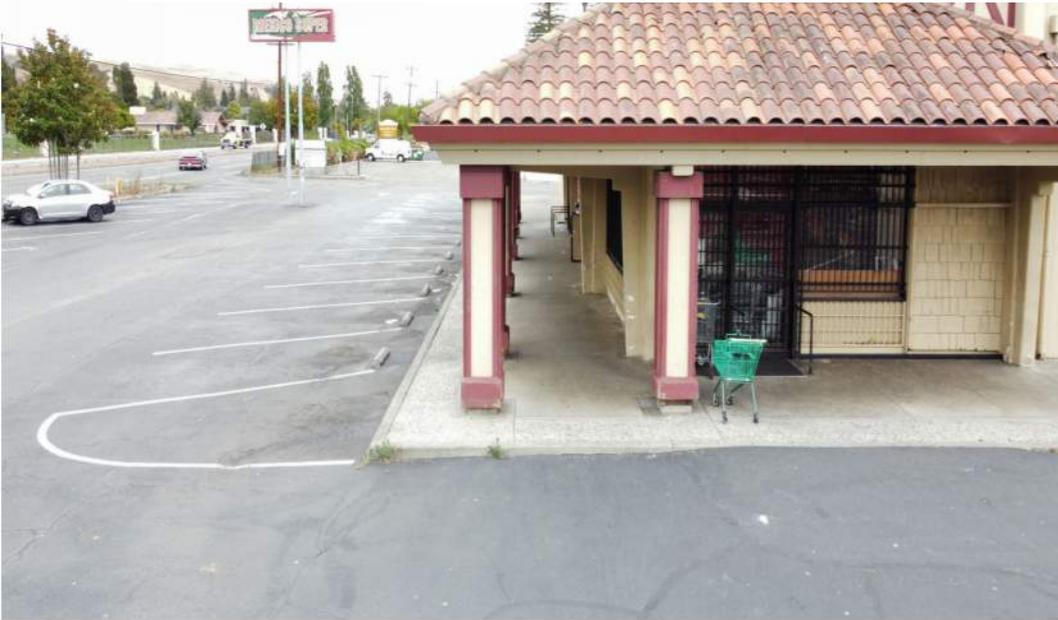
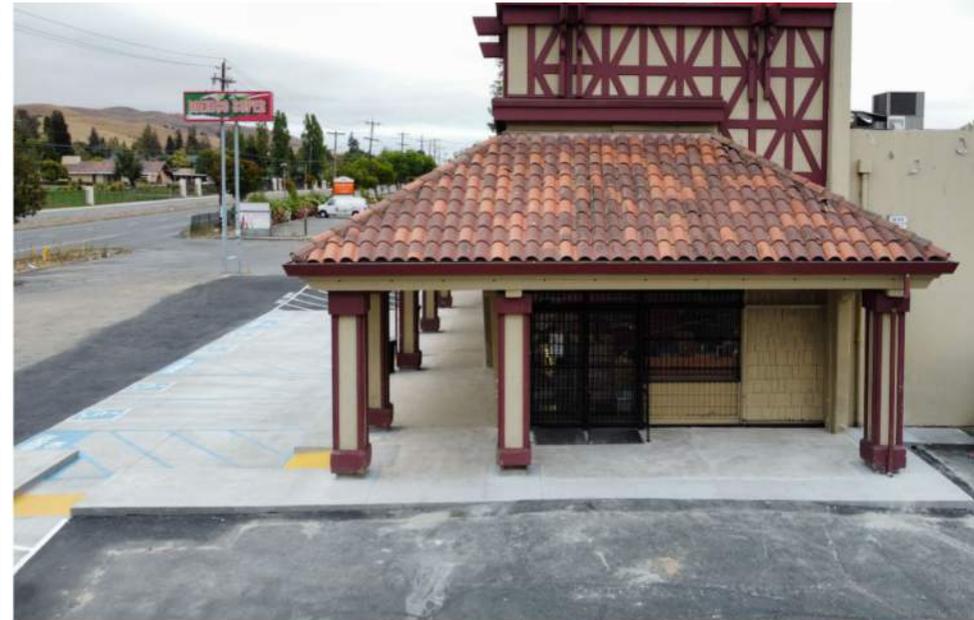
While integrating the newly sloped ADA compliant concrete parking stalls with the existing asphalt area, Protrk created a freight loading area with an even surface to the front entrance for ease and safety of large deliveries.

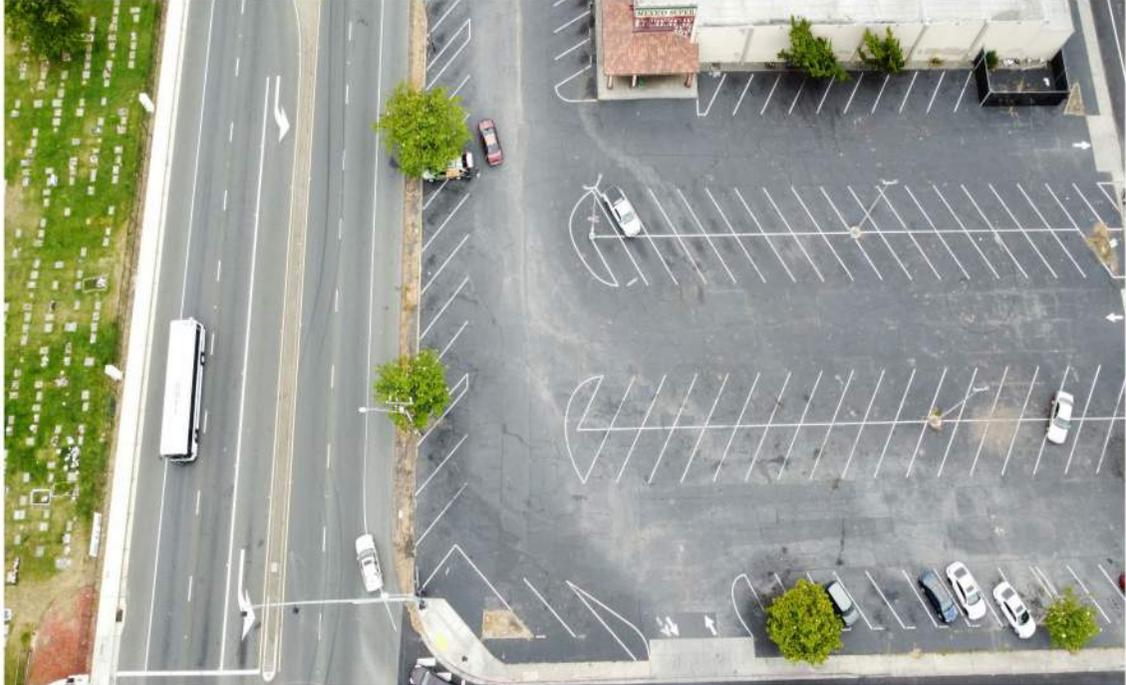
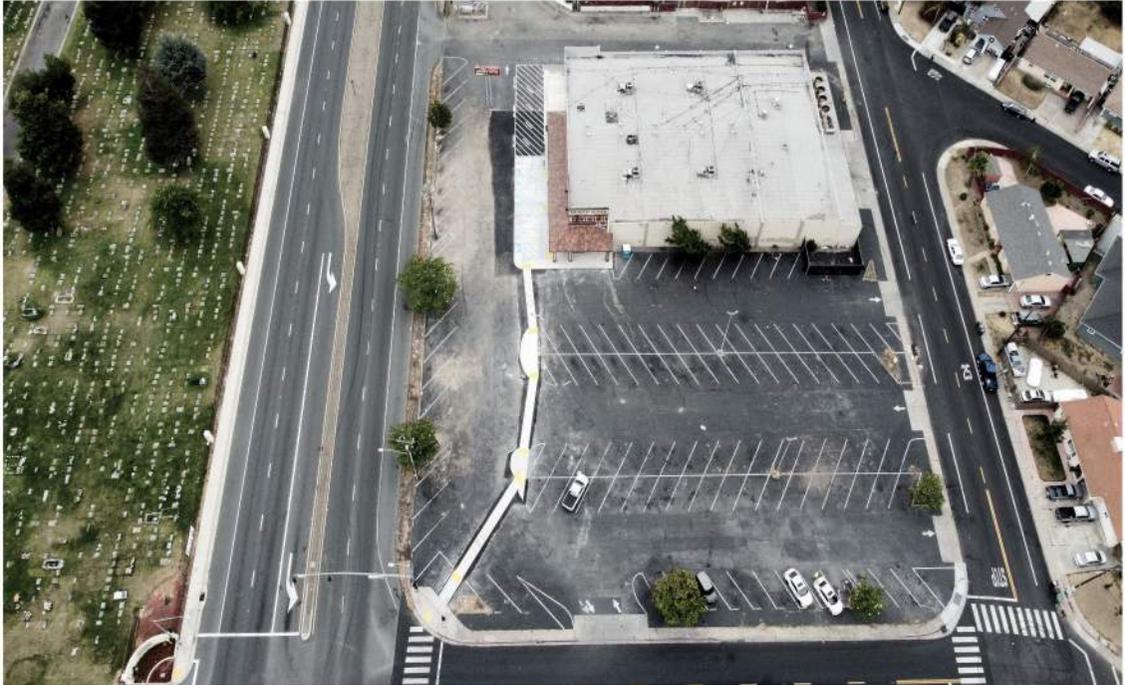
With no walk on the public street, Protrk installed a new ADA compliant concrete accessible path of travel to the nearest public walk while maintaining existing drainage and traffic patterns in the store's parking lot.
